ETL-0100

PLATFORM ORIENTATION SYSTEM TEST PROGRAM

November 1976

U.S. ARMY ENGINEER
TOPOGRAPHIC LABORATORIES
FORT BELVOIR, VA 22060

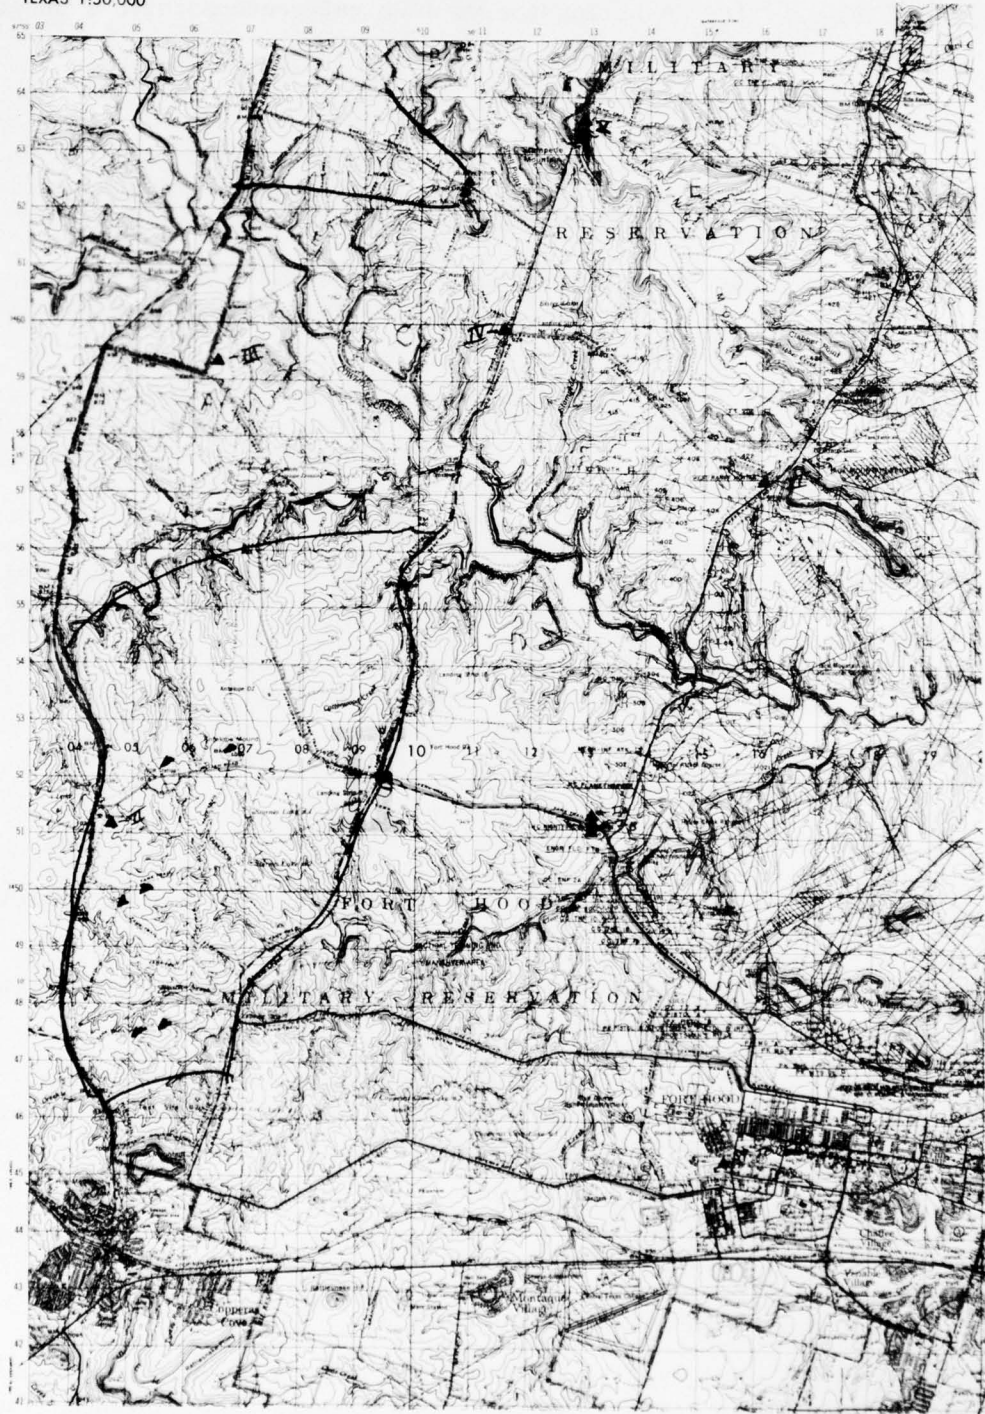
Figure 3. Map of Fort Hood.

Test Sites. Test circles 10 meters in diameter located at Fort Hood, Texas were selected at random (see figure 3). These circles were circumscribed about centers located on the following approximated UTM coordinates and along the following reference azimuth (table 2):
